Assessment of the Owego Creek Stream Restoration Project, Park Settlement Road Site: A Reevaluation of Stream Habitat and Water Quality.

By Dylan Morse, advised by Professor Aaron Strong of Hamilton College.

September 10th, 2020

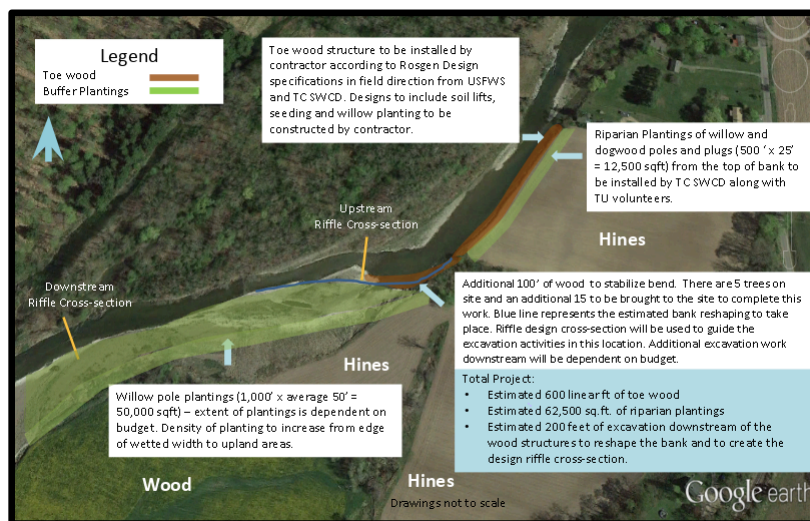
Figure 2. Displays the restoration site at Park Settlement Road as of 2015. Toe wood and buffer plantings are labeled along the ~1000-meter stretch, which is bordered on the left by woodlands and on the right by farmland (Brown, 2013, Figure 1.).

The Park Settlement Road Site was restored using the Rosgen Toe Wood Method. The method was used to stabilize banks, prevent further erosion, and create habitat for fish. Six-meter-long tree trunks with root balls were installed below low-flow levels along the outer bank of the site. The layer was covered with brush and backfill which was held in place with Coir fabric. An assortment of 3,700

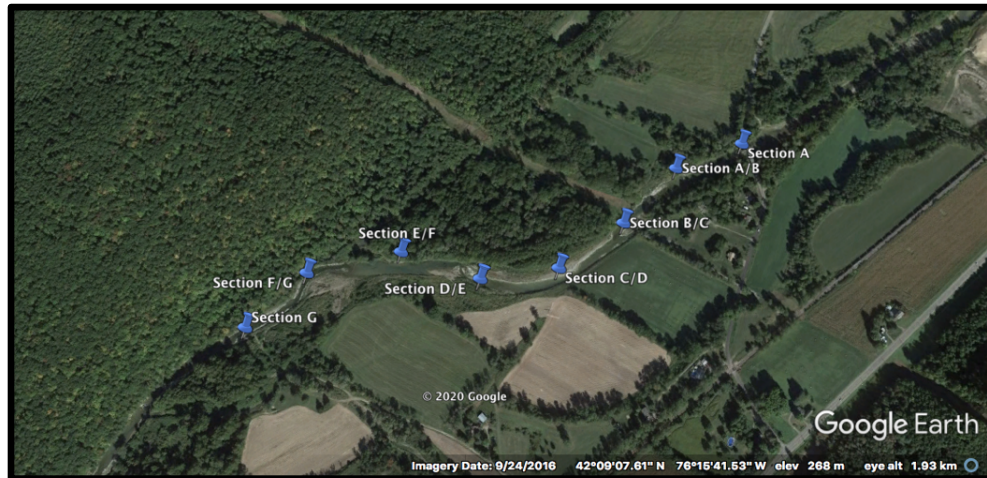
Figure 3. Shows the seven cross-sections, or study reaches, within the defined study area. The study site is 1050 meters in length (Google Earth, 2020).

downstream end of the Park Settlement Road bridge to the downstream end of the restoration site. The study area was divided into seven longitudinal reaches of 150-meters, labeled “A” through “G”, and was marked with elevation and GPS coordinates. Study reaches “A” and “B” were above the restoration site.

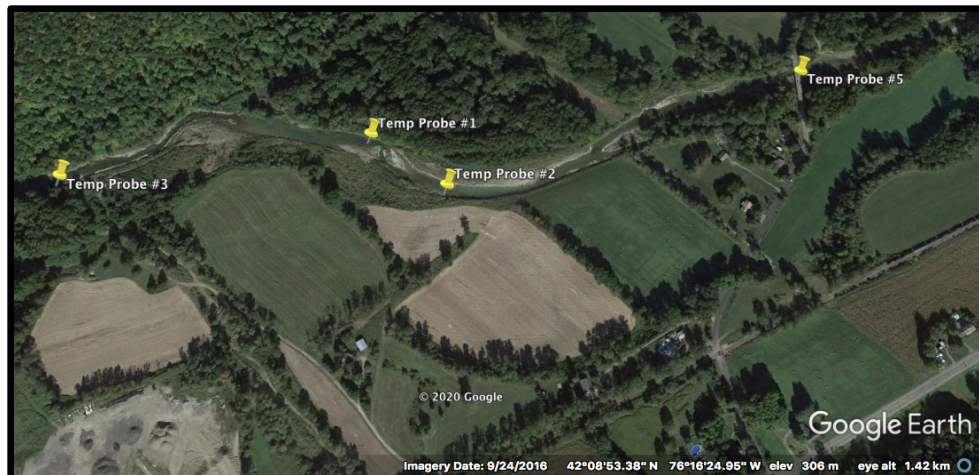
Figure 4. Identifies the locations of the four temperature probes throughout the study area. Temperature probes were located at strategic locations to identify if water temperature was changed by in specific locations by stream structure and pools, runs, and riffles (Google Earth, 2020).

Temperature probes were planted at four locations in even intervals throughout the stream. Cross-sectional data was collected within each reach at 25-meters, 75-meters, and 125-meters with labeled

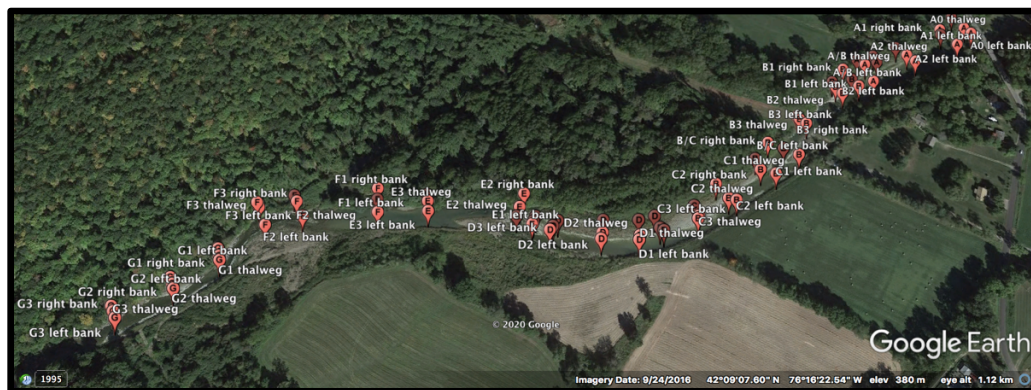
Figure 5. Shows each of the sub sectional GPS measurements taken within each cross-sectional reach. Each measurement had altitude, latitude, and longitude data (Google Earth, 2020).

subsections (i.e., A1, A2, and A3, etc.). Latitude-longitude and elevation were taken on each bank as well as the thalweg. The left-bank and right-bank were labeled when looking downstream. Four identification photographs were taken, two at the thalweg looking upstream and downstream, as well as on each bank.

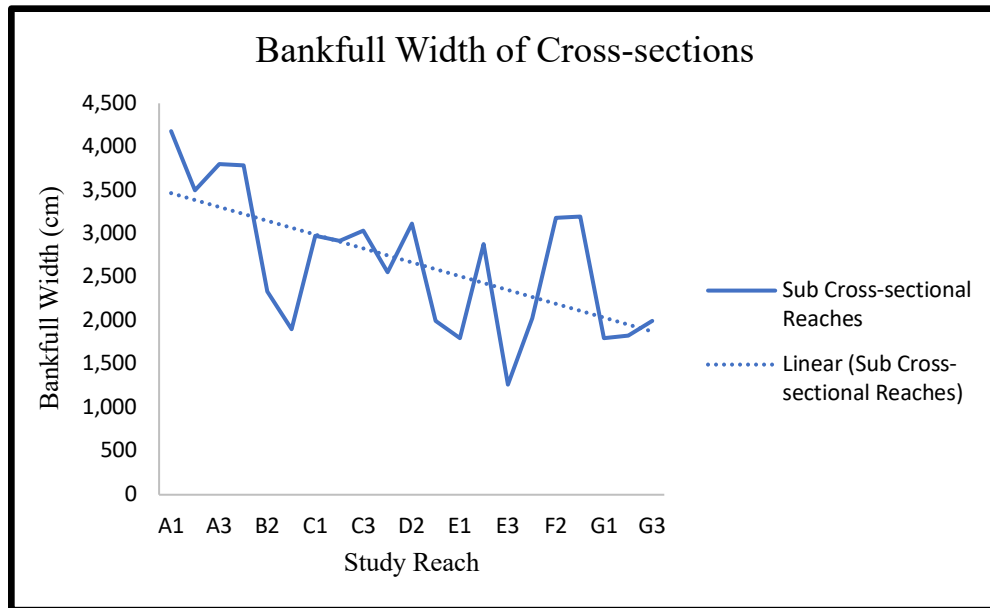
Figure 7. Shows each cross-section (A1-G3), related to each bankfull width taken. Upstream study reaches are to the left, while downstream study reaches are to the right.

The mean bankfull width ranged from 12.66-41.80 m, downstream the mean bankfull width decreased throughout the Park Settlement Site. Mean water depth and bankfull depth also decreased

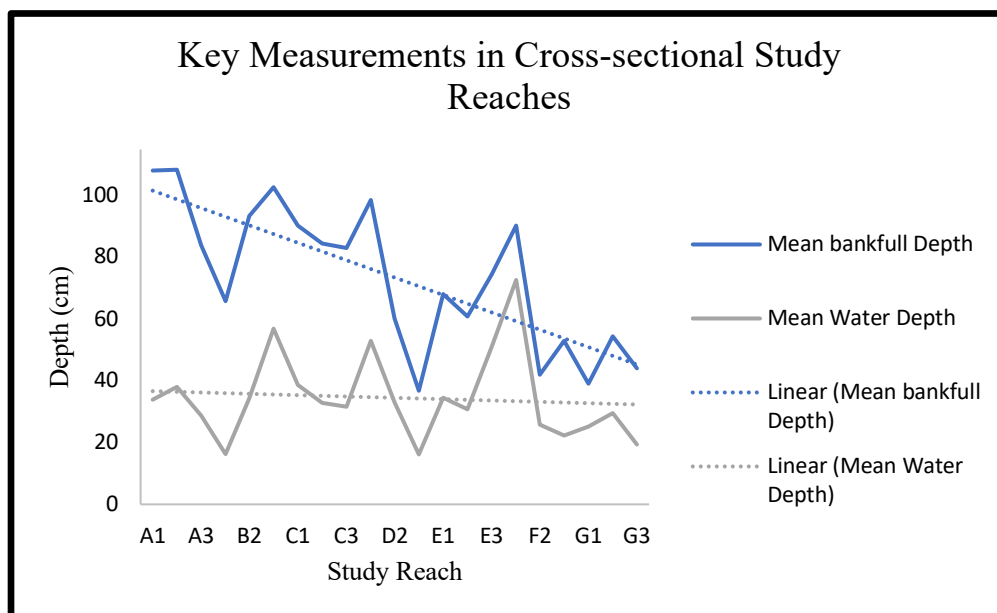
Figure 8. Relates the depth (cm) of each cross-section to its mean bankfull and mean water depth. Mean bankfull depth most noticeably decreases as you move downstream.

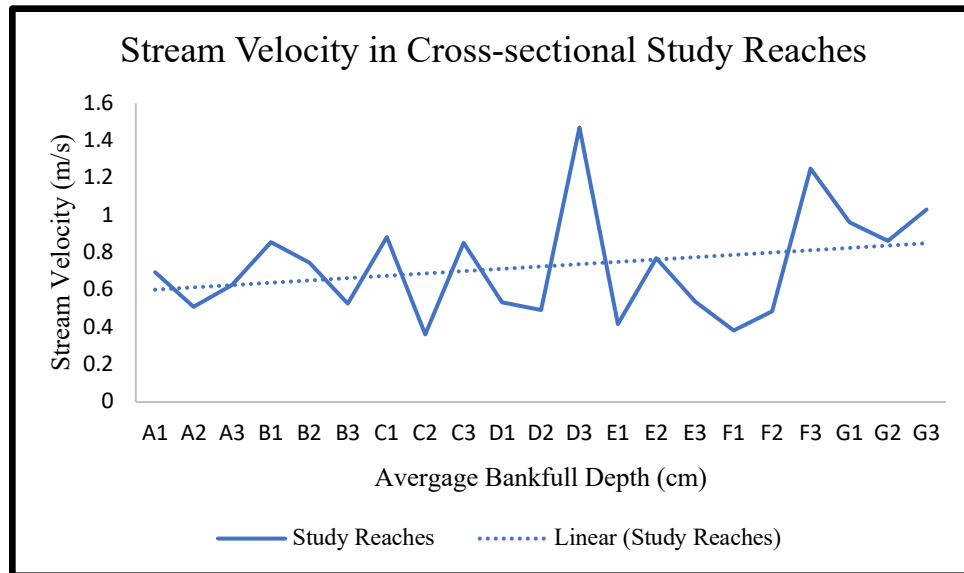
Figure 9. Finds that the decrease in bankfull width, shows in Figure 7, correlates to an increase in water velocity in downstream study sections.

throughout the site. Bankfull width correlated with an increase in stream velocity in downstream study-reaches. The width/depth ratio in each cross-section had a wide range (18.5-75.6) and increased slightly throughout the study site. On average the width/depth ratio was 34.5. Particle distributions remained similar within the study site with no apparent change between the Park Settlement Site and the reaches

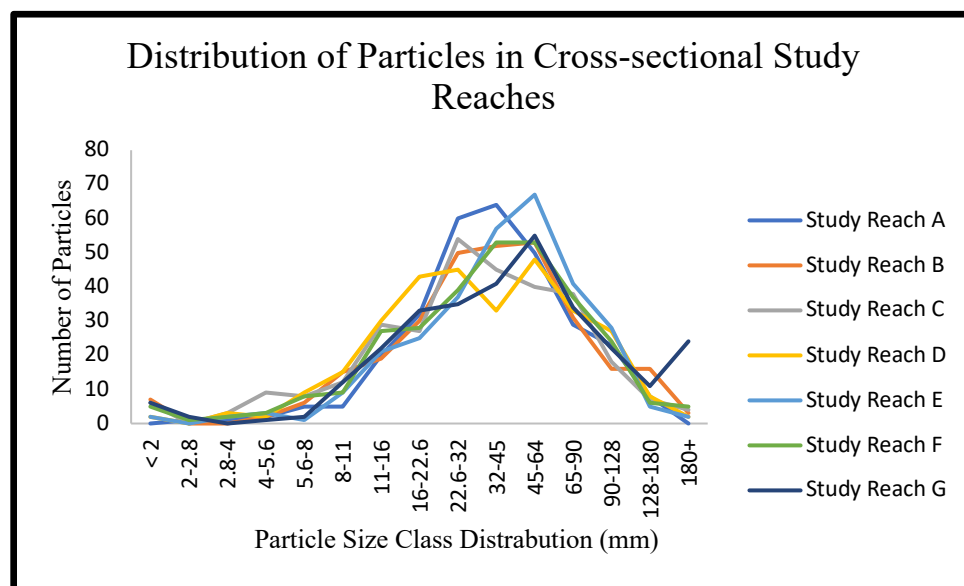
Figure 10. Shows the particle distribution for each of the seven study reaches. Sub cross-sections have been summed, and most cross-sections peak at 45-64mm.

directly upstream (study reaches *A*, *B*, and *C*). Coarse gravel was predominant in the study site (45-64 mm). The Park Settlement Road Site was classified as a high gradient Type *C* stream following the Rosgen Classification System for Natural Rivers (Natural Resources Conservation Service, 2007, p. 13). All longitudinal sections fell within the 0.38-0.64 “fair conditions” range shown in Section 6.11 with a mean score of 0.53 (Kline et al., 2004). The morphological diversity of each longitudinal section differed little in runs, riffles, and pools, which all occurred on average ≈ 1 per longitudinal reach.

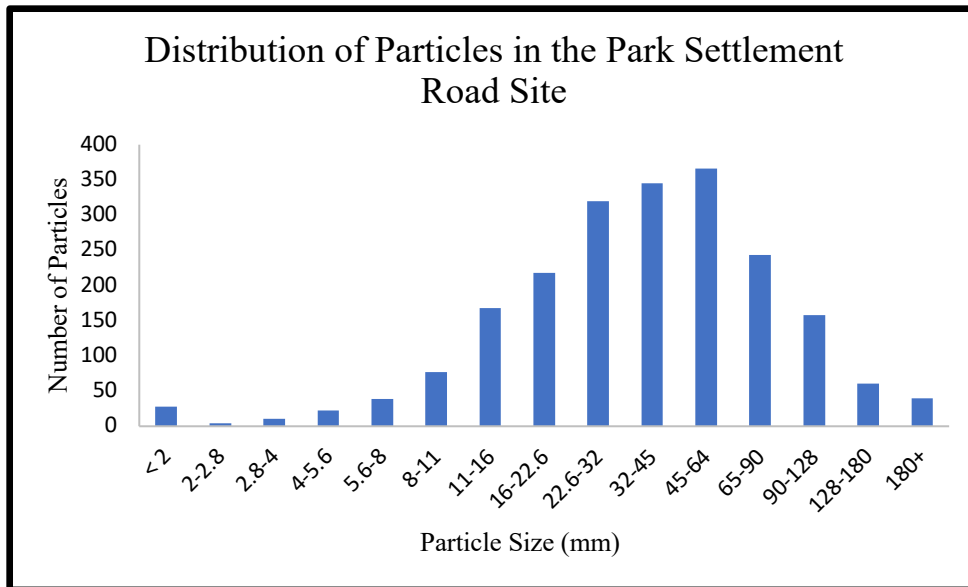
Figure 11. Shows the accumulated particle data for the entire study reach.

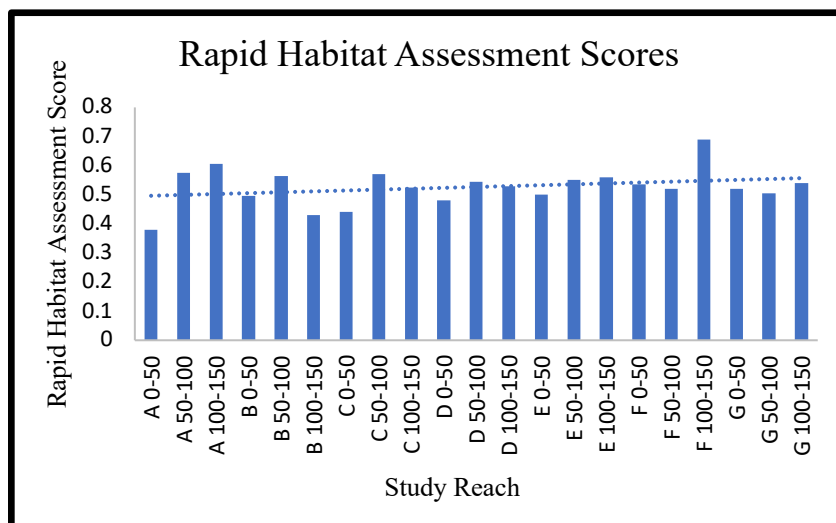
Figure 12. Relates the rapid habitat assessment score with its linear trendline. Scores trended upward towards the downstream section of the study site.

Rapid habitat assessment scores increased slightly within the restoration site compared to upstream reaches. The Coldwater Conservation Corps's Advanced Monitoring Protocol water quality score was 39.2, in the "fair" range of 20-40 (p. 15). Using the Environmental Protection Agency's Index of Biological Integrity, the stream received a score of 83.8 indicting the stream to be non-degraded (above the > 65.7 threshold) (p. 11). Electrofishing data showed a 103 fish increase from 05/07/14 to 08/18/2016. Brook trout increased from 0 individuals to 66, and brown trout increased from 1 individual to 14. Dissolved oxygen increased from 8.6 to 11.0 while pH remained at 8.1. Temperature steadily increased throughout the summer from 18 °C to 20.5 °C. Three temperature probes were retrieved for data collection to monitor water temperatures at depths > 1 foot, the fourth captured surface temperature and was 5-8°C warmer due to the direct exposure to sunlight.

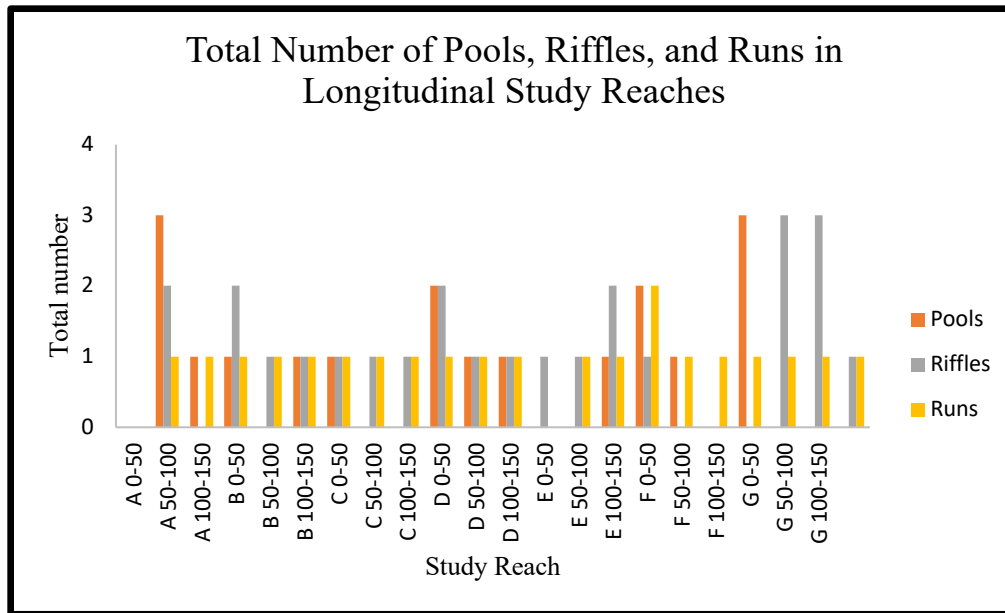
Figure 13. Shows the number of woody debris, pools, runs, and riffles in each longitudinal reach. The spike is due to the use of the toe wood in used to repair the outer bank in the middle of the study site.

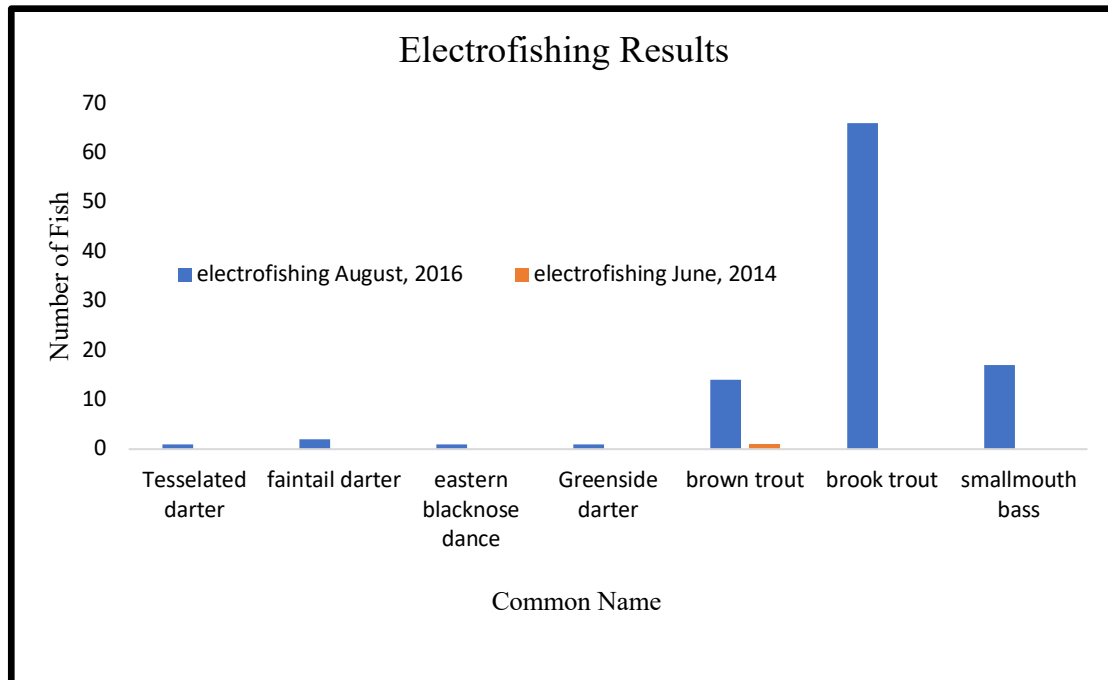
Figure 14. Displays the results from New York State electroshocking conducted in June 2014 (before restoration) and August 2016 (after restoration).

The strongest data to prove that restoration benefitted the East Branch of Owego Creek is the dramatic increase in fish populations from 2014 to 2016. Overall, every population sampled increased over the two-year period with an overall 106 fish increase. Brook trout populations increased from 0 to 66 individuals, and smallmouth bass and brown trout populations both increased significantly as well.

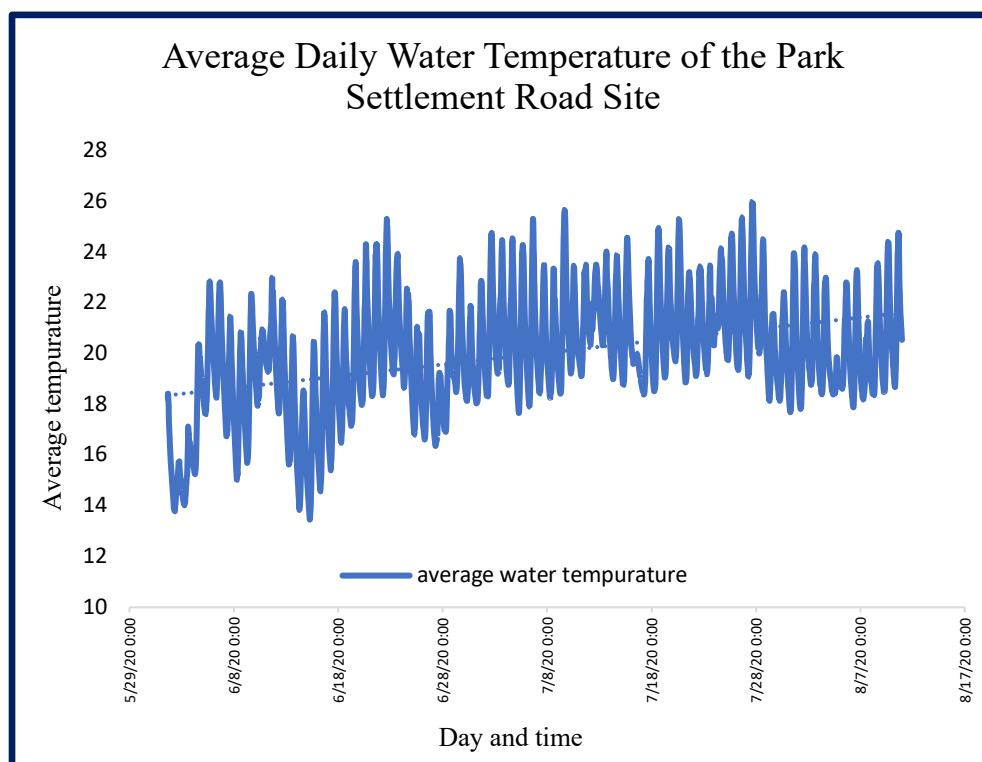
Figure 15. Shows daily average temperature taken at half-hour intervals. Data is averaged from three temperature loggers > 1 foot below surface level. Daily temperature variation is due to day/night temperature changes. An increase was water temperature throughout the summer months.

The pH of the creek remained constant throughout restoration from 2014 to 2016 at a pH of 8.1, within the optimal range for most aquatic life (Myers et al., 2018). Water temperatures of 18 °C initially exceeded the optimal range for range for trout survival, 12.4-15.4°C, (Soil Conservation Service, 1986) and moved up into the lethal zone for trout (> 20°C) (Myers et al., 2018). Dissolved oxygen levels increased from 8.6-11.0 mg/L. Levels below 8.0 lead to moderate reproduction impairment while levels ≥ 11 mg/L are optimal for trout survival and reproduction (Carter, 2005).
