## **Room(s) for More: A Communal Dwelling or Family Home at Ephrata**

*By Jeff Bach and Nick Siegert*

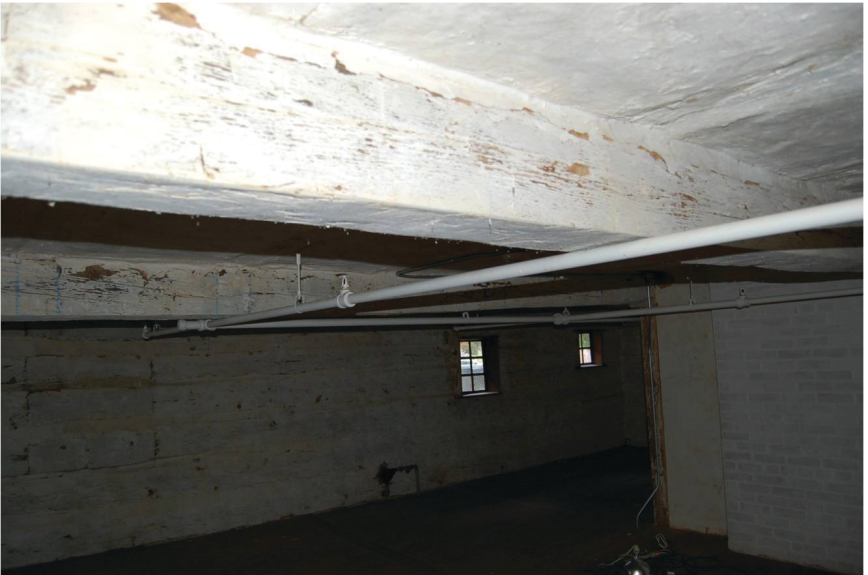
Figure 10. First floor of Weaver's House looking north showing both summer beams.

One of the most unusual structural features of the Weaver's House is its two summer beams. Typically a single-family home contained only one summer beam in the center of the house.<sup>29</sup> A summer beam is commonly defined as a major, and usually massive, horizontal timber that spans the plates of a structure from gable end to gable end. Its purpose is to carry the load of the joists above it.<sup>30</sup> The use of two summer beams does not appear in any other surviving historic structures at Ephrata, nor in comparable Germanic residential buildings of the same era. As a comparison, the Hans Herr House, a 1719 historic Germanic single family home, has only one summer beam.<sup>31</sup> There are a number of old homes that use two or more summer beams in their construction but they tend to be larger homes with more complicated structures. Many barns with three bays have two summer beams.<sup>32</sup> The Weaver's House offers no internal evidence today for why two summer beams were used. Could the sheer size of this building along with the use of two summer beams imply that it had another purpose? Determining exactly how the original summer beams functioned in this structure is also complicated by the fact they were replaced during the 1963 restoration.<sup>33</sup>

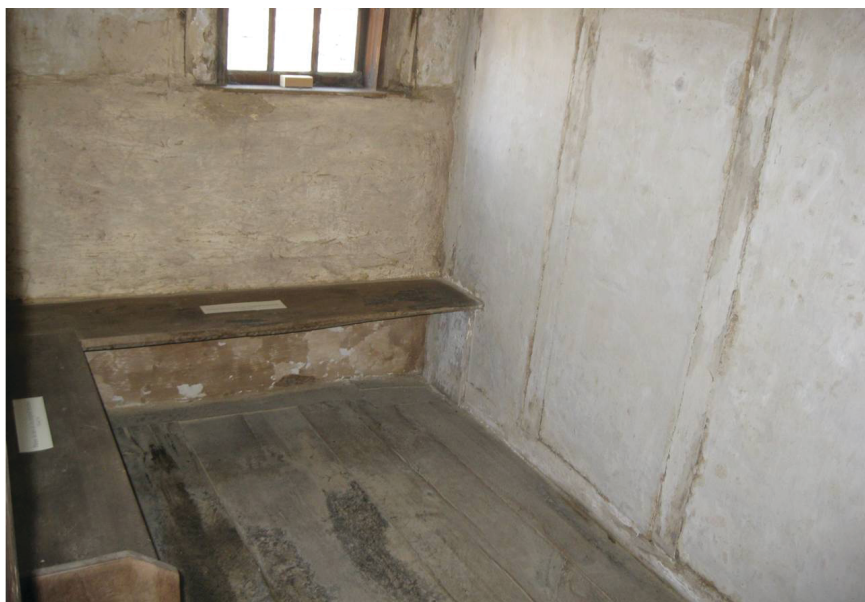
Figure 11. Third floor of Saron showing original cell, bench, and wall construction.

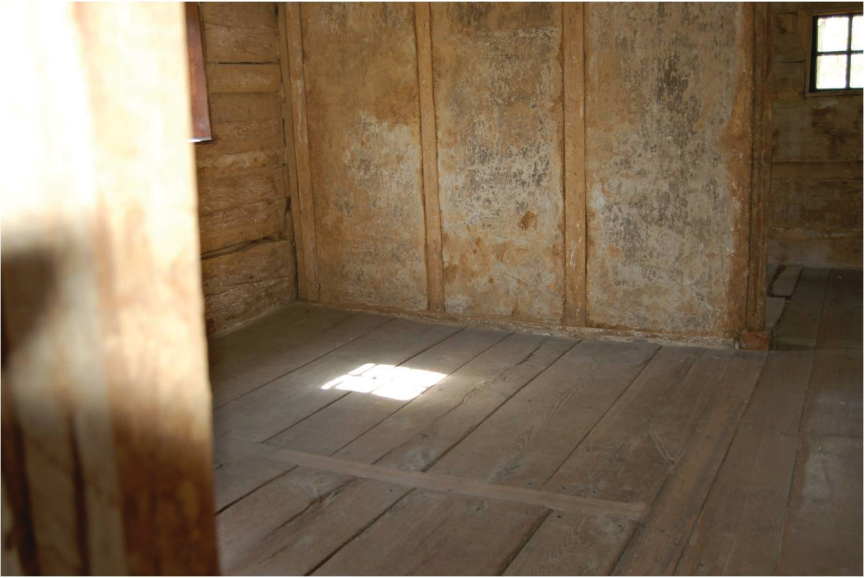
Figure 13. Second floor of Saron showing area where cell wall was removed forming larger room. Notice patch on floor where wall used to stand.

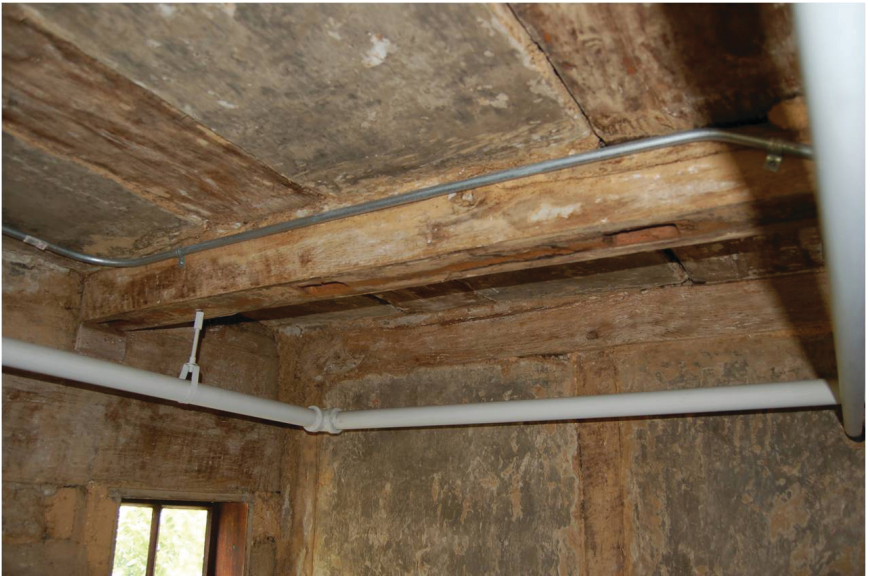
Figure 14. Second floor of Saron with ceiling joist and mortise holes where wall studs used to be. Also notice back wall with joist and stud locations.

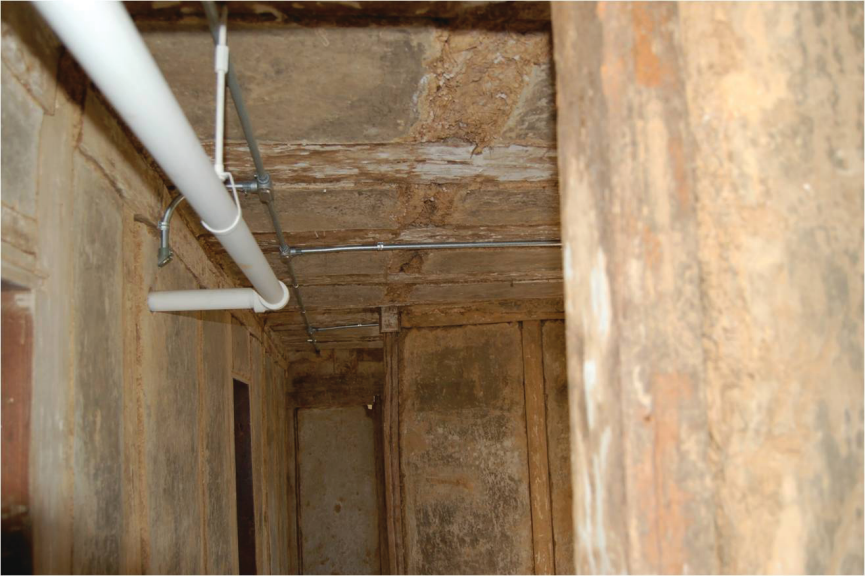
Figure 15. Second floor of Saron. Former hallway and wall have been removed. Notice where joist running along ceiling has been removed. Notice vertical grove running up vertical stud to hold lath.

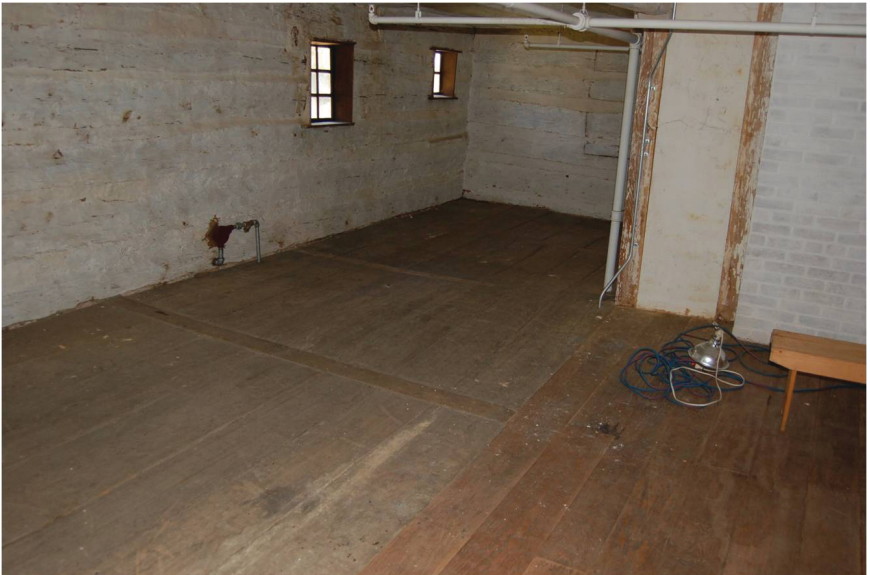
Figure 16. Second floor of Weaver's House showing floor patches where cell walls used to stand.

On the second floor of the Weaver's House, the lengths of the two floor patches are 103" and 103½" in length. These two floor patches are easily visible on the north end of the building. In the second floor of the Weaver's House on the floor of the north side of the building, the comparable floor patches where dividing walls were removed in Saron are 113½", 94½", and 100½" in length. The patches in the Weaver's House are pictured on a diagram (figure 3) drawn around 1948 by G. Edwin Brumbaugh, the first restoration architect, hired by the State of Pennsylvania to restore the Cloister buildings.<sup>44</sup>

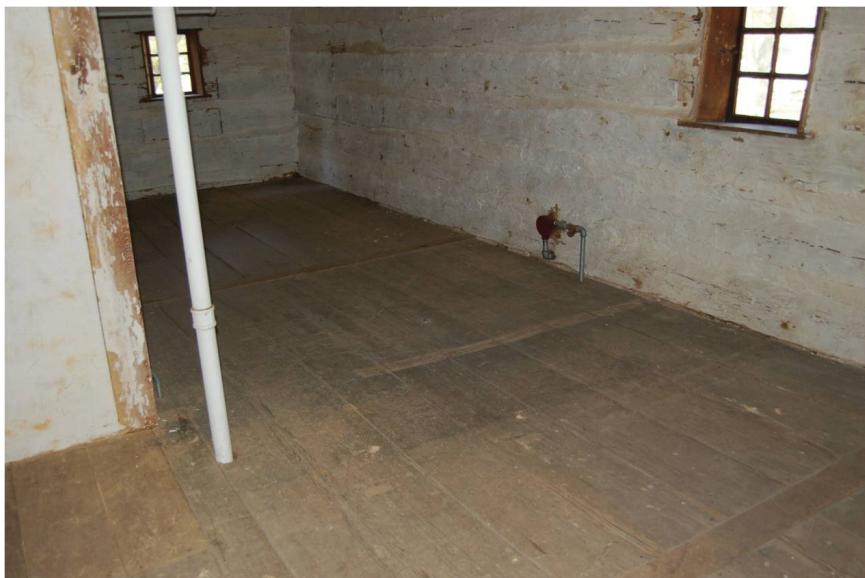
Figure 17. Second floor of the Weaver's House from the opposite angle showing floor patches denoting possible location of cell walls.
